APPENDICES (Part of this document):

2015 Asbestos Information Sheets for Locations confirmed as containing / presumed to contain ACM's.

2020 Survey Photographs showing locations confirmed in 2015 survey as containing / presumed to contain ACM's.

SOUTH TYNEDALE RAILWAY

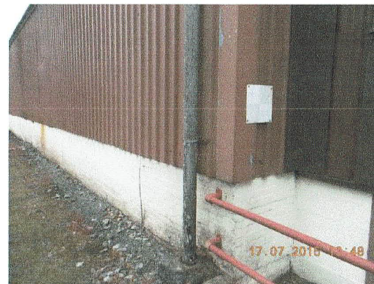
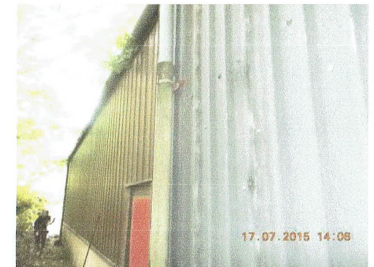
Location Ref:AS04

Asbestos Information		Inspection Number:	Zer/st/ry/11
Site Reference	Zer/st/ry/2015	Client Name	South Tynedale Railway
Address	South Tynedale Railway, Alston, CA9 3JB		
Level/Floor	Ground (Shed 2)		
Room/Area	External Areas		
Element	Drain Pipes (Front & Rear)		
Inspection Method	Sample Taken		
Inspection Date	17 th July 2015		
Material Assessment			
Product Type	Non Friable Material		
Extent of Damage	Medium Damage		
Surface Treatment	Cement/Enclosed Spray or Lagging/Sealed Board		
Overall Asbestos Type	Chrysotile		
Material Assessment	5.0		
Priority Assessment			
Occupant Activity	Low Disturbance		
Disturbance (Accessibility)	Easily Disturbed		
Disturbance (Extent)	Less Than 10m ² or 10 lm		
Disturbance (Location)	Outdoors		
Exposure (Usage Time)	Less than 1 hour		
Exposure (Freq. of Use)	Infrequent		
Exposure (No. of Occupants)	None		
Maintenance (Freq. Of)	Less Than Once per Year		
Maintenance (Type Of)	Low Disturbance

Priority Assessment	3.0		
Total Risk Assessment		Recommendation:	Remove if impacted by refurbishments
Score	8.0	Score Category	Very Low Risk

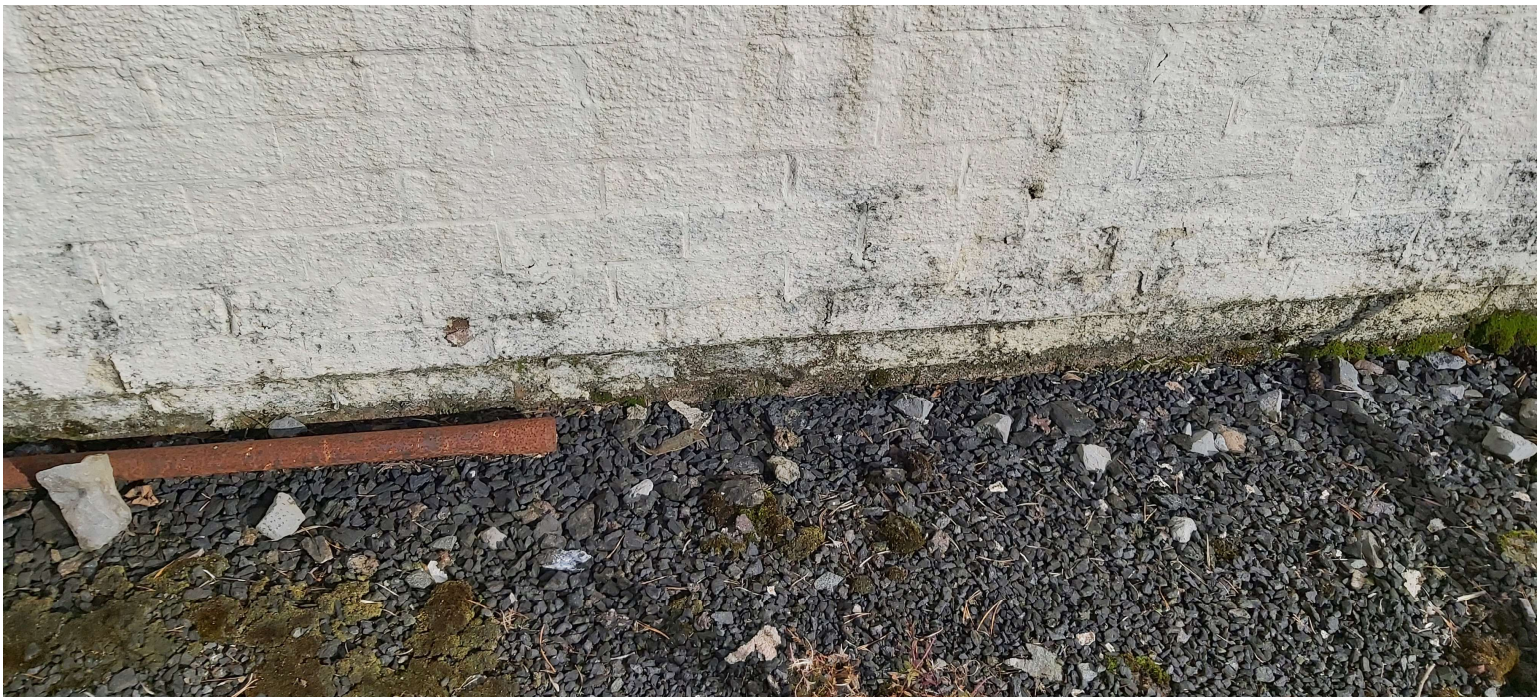
2020 Asbestos Survey
Ref: Zer/st/ry/12
Location Ref AS05
Location: Outside Shed 2

Asbestos Information		Inspection Number:	Zer/st/ry/12
Site Reference	Zer/st/ry/2015	Client Name	South Tynedale Railway
Address	South Tynedale Railway, Alston, CA9 3JB		
Level/Floor	Ground (Shed 2)		
Room/Area	External Areas		
Element	Damp Proof Course		
Inspection Method	Sample Taken		
Inspection Date	17 th July 2015		
Material Assessment			
Product Type	Non Friable Material		
Extent of Damage	Low Damage		
Surface Treatment	Reinforced Composite Material		
Overall Asbestos Type	Chrysotile		
Material Assessment	3.0		
Priority Assessment			
Occupant Activity	Rare Disturbance		
Disturbance (Accessibility)	Normally Inaccessible		
Disturbance (Extent)	More Than 50 m2 or 50 lm		
Disturbance (Location)	Outdoors		
Exposure (Usage Time)	Less than 1 hour		
Exposure (Freq. of Use)	Infrequent		
Exposure (No. of Occupants)	None		
Maintenance (Freq. Of)	Less Than Once per Year		
Maintenance (Type Of)	Low Disturbance		
Priority Assessment	2.0

Total Risk Assessment		Recommendation:	Remove if impacted by refurbishments
Score	5.0	Score Category	Very Low Risk

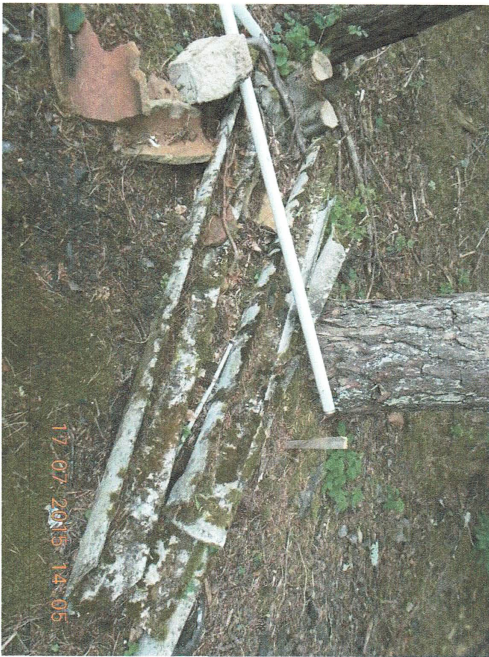
Level/Floor	Ground (Shed 2)
Room/Area	External Areas
Element	Debris
Inspection Method	Sample Taken
Inspection Date	17 th July 2015

Material Assessment	
Product Type	Non Friable Material
Extent of Damage	High Damage
Surface Treatment	Cement/Enclosed Spray or Lagging/Sealed Board
Overall Asbestos Type	Chrysotile
Material Assessment	6.0

Priority Assessment	
Occupant Activity	Low Disturbance
Disturbance (Accessibility)	Easily Disturbed
Disturbance (Extent)	Less Than 10m2 or 10 lm
Disturbance (Location)	Outdoors
Exposure (Usage Time)	Less than 1 hour
Exposure (Freq. of Use)	Infrequent
Exposure (No. of Occupants)	None
Maintenance (Freq. of Use)	Less Than Once per Year
Maintenance (Type of)	Low Disturbance
Priority Assessment	3.0

Total Risk Assessment		Recommendation:	Remove
Score	9.0	Score Category	Very Low Risk

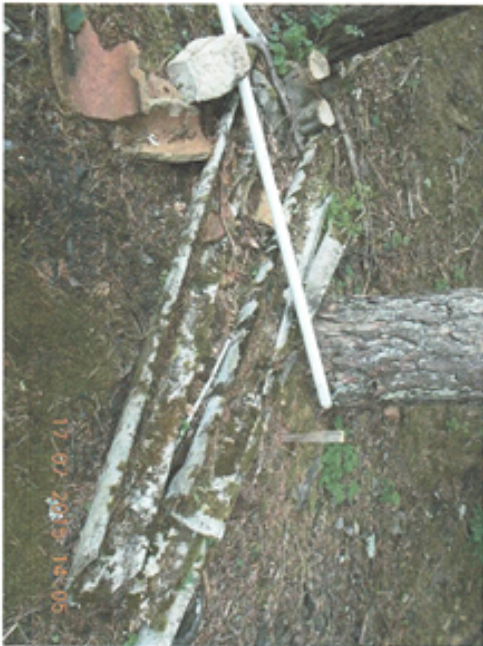
2015 Asbestos Survey
 Ref: Zer/st/ry/13
 Location Ref: AS06
 Location:
 Debris on Ground Outside Shed 2

Asbestos Information		Zer/st/ry/2015	Inspection Number:	Zer/st/ry/13
Site Reference	South Tynedale Railway, Alston, CA9 3JB		Client Name	South Tynedale Railway
Address				
Level/Fiber	Ground (Shed 2)			
Room/Area	External Areas			
Element	Debris			
Inspection Method	Sample Taken			
Inspection Date	17 th July 2015			
Material Assessment				
Product Type	Non Friable Material			
Extent of Damage	High Damage			
Surface Treatment	Cement/Enclosed Spray or Lapping/Sealed Board			
Overall Asbestos Type	Chrysotile			
Material Assessment	6.0			
Priority Assessment				
Occupant Activity	Low Disturbance			
Disturbance (Accessibility)	Easily Disturbed			
Disturbance (Extent)	Less Than 10m ² or 10 km			
Disturbance (Location)	Outdoors			
Exposure (Usage Time)	Less than 1 hour			
Exposure (Freq. of Use)	Infrequent			
Exposure (No. of Occupants)	None			
Maintenance (Freq. of Use)	Less Than Once per Year			
Maintenance (Type of)	Low Disturbance

Priority Assessment	3.0			
Total Risk Assessment				
Score	9.0		Recommendation:	Remove
			Score Category	Very Low Risk

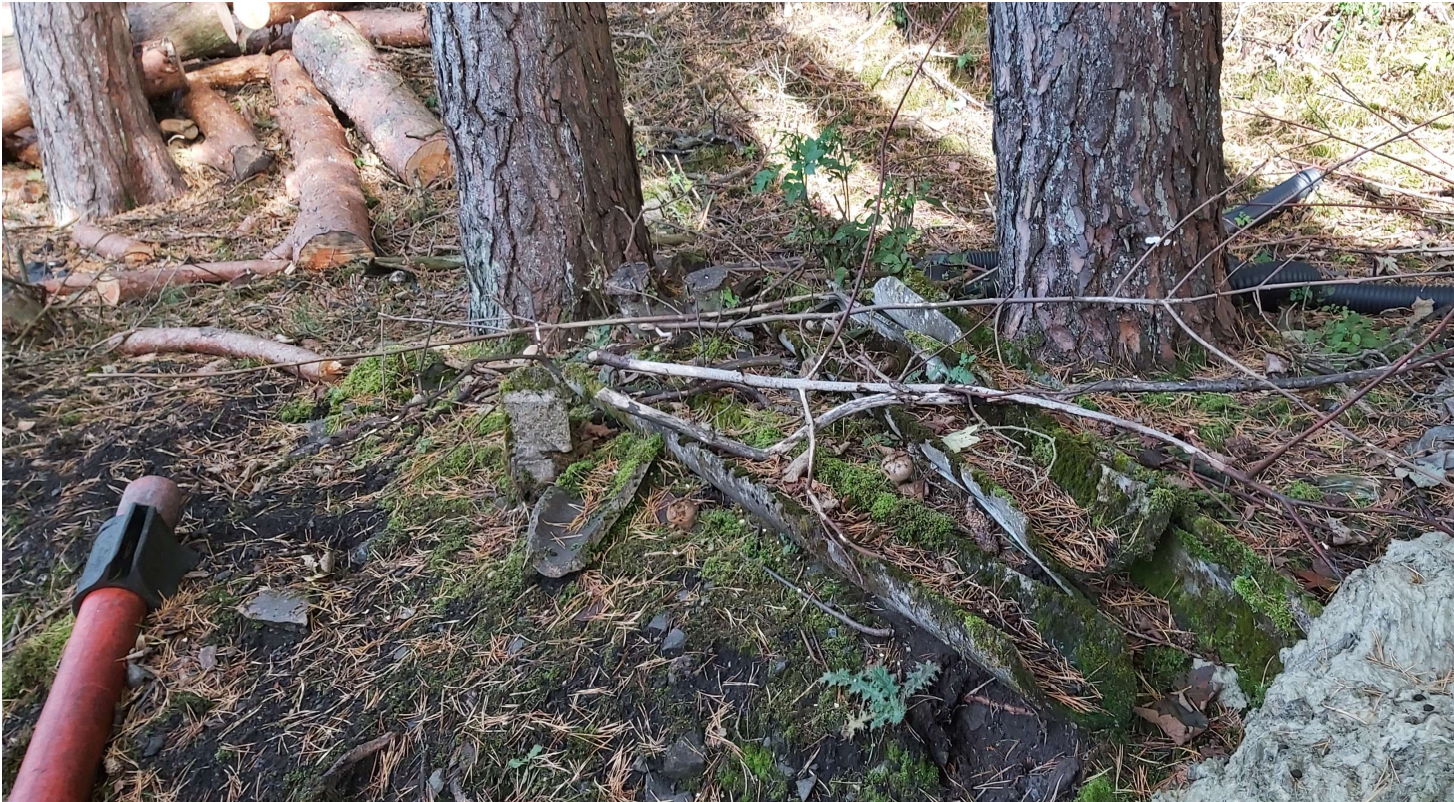
Location Ref: AS06

Location: Debris on Ground Outside Shed 2

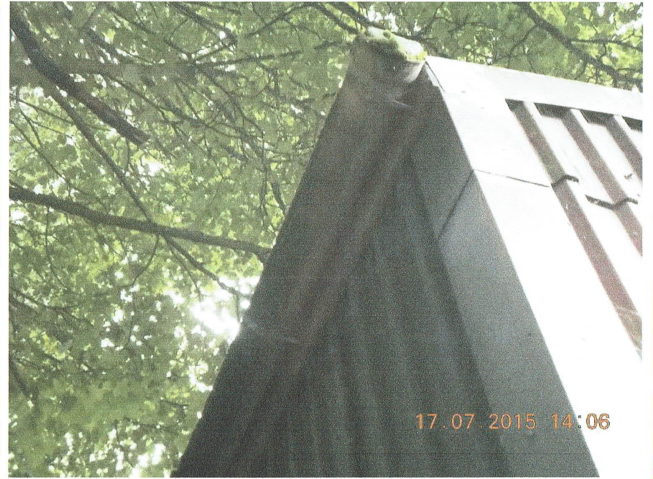
Location Ref :AS07

Asbestos Information		Inspection Number:	Zer/st/ry/14
Site Reference	Zer/st/ry/2015	Client Name	South Tynedale Railway
Address	South Tynedale Railway, Alston, CA9 3JB		
Level/Floor	Ground (Shed 2)		
Room/Area	External Areas		
Element	Cement Gutter		
Inspection Method	Sample Taken		
Inspection Date	17 th July 2015		
Material Assessment			
Product Type	Non Friable Material		
Extent of Damage	Low Damage		
Surface Treatment	Cement/Enclosed Spray or Lagging/Sealed Board		
Overall Asbestos Type	Chrysotile		
Material Assessment	4.0		
Priority Assessment			
Occupant Activity	Low Disturbance		
Disturbance (Accessibility)	Easily Disturbed		
Disturbance (Extent)	Less Than 10m ² or 10 lm		
Disturbance (Location)	Outdoors		
Exposure (Usage Time)	Less than 1 hour		
Exposure (Freq. of Use)	Infrequent		
Exposure (No. of Occupants)	None		
Maintenance (Freq. Of)	Less Than Once per Year		
Maintenance (Type Of)	Low Disturbance		
Priority Assessment	3.0

Total Risk Assessment		Recommendation:	Remove if impacted by refurbishments
Score	7.0	Score Category	Very Low Risk
