APPENDICES (Part of this document):

2015 Asbestos Information Sheets for Locations confirmed as containing / presumed to contain ACM's.

SOUTH TYNEDALE RAILWAY

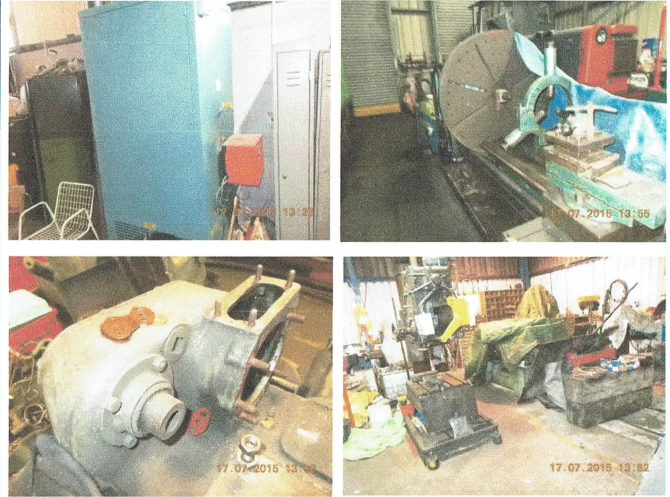
2015 Asbestos Survey
 Ref: NST 01
 Location Ref:AS09
 Location:
 General View
 Old Electrical Switchgear

Asbestos Information		Inspection Number:	NST02
Site Reference	Zer/st/ry/2015	Client Name	South Tynedale Railway
Address		South Tynedale Railway, Alston, CA9 3JB	
Level/Floor	Ground		
Room/Area	Various Areas		
Element	Older Machinery		
Inspection Method	No Sample Taken		
Inspection Date	17 th July 2015		
Material Assessment			
Product Type	Non Friable Material		
Extent of Damage	Good Condition		
Surface Treatment	Cement/Enclosed Spray or Lagging/Sealed Board		
Overall Asbestos Type	Chrysotile (Presumed)		
Material Assessment	3.0		
Priority Assessment			
Occupant Activity	Rare Disturbance		
Disturbance (Accessibility)	Normally Inaccessible		
Disturbance (Extent)	Small amounts or Items		
Disturbance (Location)	Large Rooms/Well Ventilated		
Exposure (Usage Time)	Less than 1 hour		
Exposure (Freq. of Use)	Infrequent		
Exposure (No. of Occupants)	None		
Maintenance (Freq. Of)	Less Than Once per Year		
Maintenance (Type Of)	Low Disturbance

Priority Assessment	2.0		
Total Risk Assessment		Recommendation:	Remove if impacted by refurbishments
Score	5.0	Score Category	Very Low Risk

Older machinery may contain asbestos in the form of gaskets

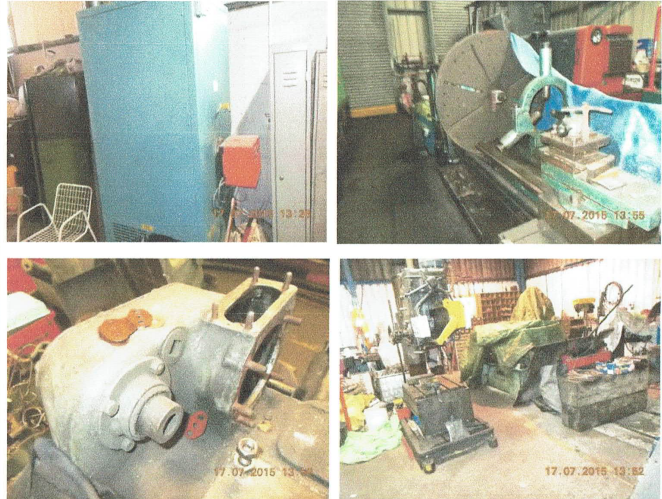
2015 Asbestos Survey
 Ref: NST 02
 Location Ref: AS09
 Location:
 General View of
 Old Machinery

Asbestos Information		Inspection Number:	NST02
Site Reference	Zer/st/ry/2015	Client Name	South Tynedale Railway
Address	South Tynedale Railway, Alston, CA9 3JB		
Level/Floor	Ground		
Room/Area	Various Areas		
Element	Older Machinery		
Inspection Method	No Sample Taken		
Inspection Date	17 th July 2015		
Material Assessment			
Product Type	Non Friable Material		
Extent of Damage	Good Condition		
Surface Treatment	Cement/Enclosed Spray or Lagging/Sealed Board		
Overall Asbestos Type	Chrysotile (Presumed)		
Material Assessment	3.0		
Priority Assessment			
Occupant Activity	Rare Disturbance		
Disturbance (Accessibility)	Normally Inaccessible		
Disturbance (Extent)	Small amounts or Items		
Disturbance (Location)	Large Rooms/Well Ventilated		
Exposure (Usage Time)	Less than 1 hour		
Exposure (Freq. of Use)	Infrequent		
Exposure (No. of Occupants)	None		
Maintenance (Freq. Of)	Less Than Once per Year		
Maintenance (Type Of)	Low Disturbance

Priority Assessment	2.0		
Total Risk Assessment		Recommendation:	Remove if impacted by refurbishments
Score	5.0	Score Category	Very Low Risk

Older machinery may contain asbestos in the form of gaskets
