2015 Asbestos Survey
Ref: Zer/st/ry/11
Location Ref:AS04
Location: Ground Outside Shed 2

Asbestos Information		**Inspection Number:**	**Zer/st/ry/11**
Site Reference	**Zer/st/ry/2015**	**Client Name**	**South Tynedale Railway**
Address	South Tynedale Railway, Alston, CA9 3JB

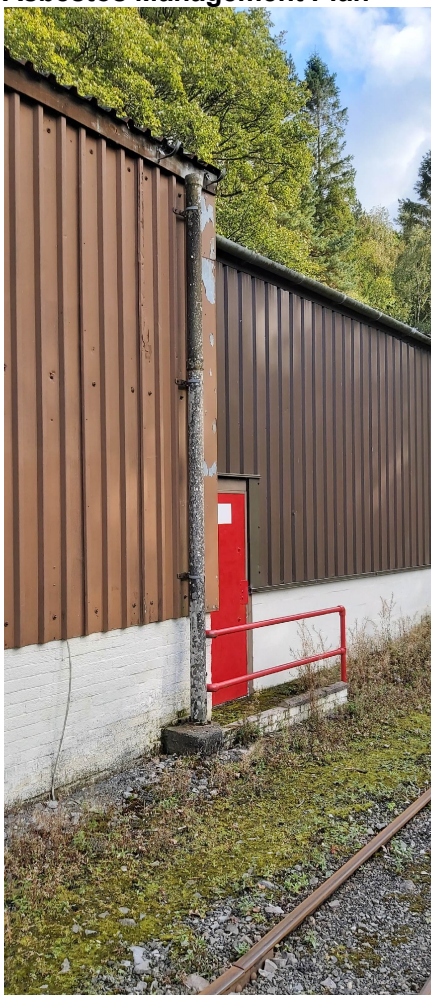
2020 Asbestos Survey – Photograph – Ref: Zer/st/ry/11
Location Ref: AS05
Location: Ground Outside Shed 2

Level/Floor	Ground (Shed 2)
Room/Area	External Areas
Element	Drain Pipes (Front & Rear)
Inspection Method	Sample Taken
Inspection Date	17th July 2015
Material Assessment	
Product Type	Non Friable Material
Extent of Damage	Medium Damage
Surface Treatment	Cement/Enclosed Spray or Lagging/Sealed Board
Overall Asbestos Type	Chrysotile
Material Assessment	**5.0**
Priority Assessment	
Occupant Activity	Low Disturbance
Disturbance (Accessibility)	Easily Disturbed
Disturbance (Extent)	Less Than 10m2 or 10 lm
Disturbance (Location)	Outdoors
Exposure (Usage Time)	Less than 1 hour
Exposure (Freq. of Use)	Infrequent
Exposure (No. of Occupants)	None
Maintenance (Freq. Of)	Less Than Once per Year
Maintenance (Type Of)	Low Disturbance
Priority Assessment	**3.0**

Total Risk Assessment		**Recommendation:**	**Remove if impacted by refurbishments**
Score	**8.0**	**Score Category**	**Very Low Risk**
